# Intel<sup>®</sup> Communications Chipset 8900 Series

Specification Update

*May 2014*

Document Number: 328000-005US

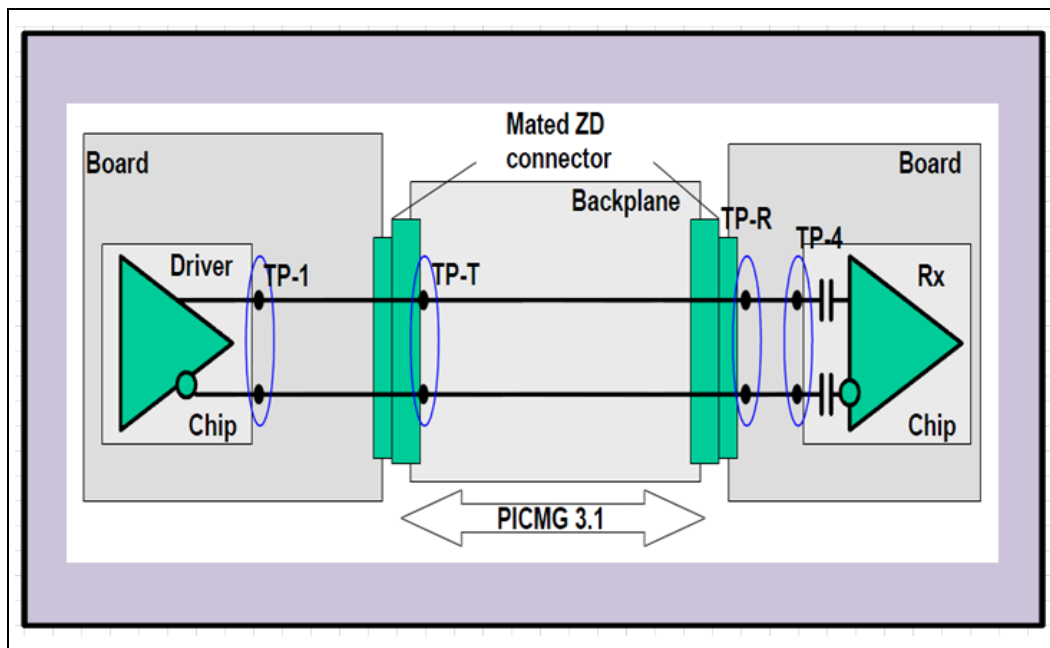
**Figure 2. 1000BASE-BX/FC-Pi Transmitter Electrical Specifications**

**75. GbE: GbE Interface Transmit Voltage Level Specification Violation**

**Implication:** Although this is a specification violation, it does not affect the functional operation of the interface.

**Workaround:** Ensure that the signal routing length from TP-1 to TP-4 is greater than 10". Refer to *Intel® Communications Chipset 8900 Series Platform Design Guide (PDG)* for maximum routing length. (See [Figure 2.](#))
